CENTER
LABORATORY
TECHNICAL REPORT

FIELD EVALUATION OF TANK TRACK PAD FAILURES

Department of Army Project Number 1L162601AH91

April, 1983

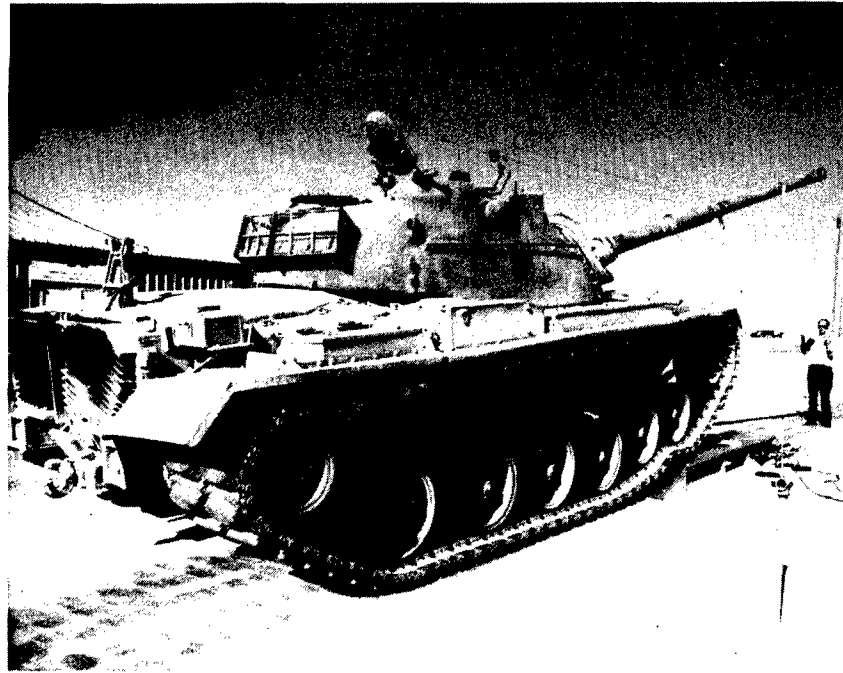
Figure 1. Experimental setup used in the pad deformation studies (View 1).

The pad deformation studies were done using a high speed motion picture camera to record on film the deformation of the T142 track. The movie generated here also gave us valuable information on the kinematics and characteristics of track operation which was helpful in establishing a mechanical model of the track. The experimental setup is shown in Figures 1 and 2. One track of the tank was driven over a ramp and a movie was made of the track from both the side and underside of the pad. The ramp height was 11 1/2 inches. The track that was not being studied was supported by a hardwood beam approximately 11 1/2 inches high. Thus, the tank was level during testing. The length of the ramp was only about 6.1 feet, and since tests were started with one track on the ramp, speeds were limited. We estimate that the tank velocity varied between zero and seven miles/hour during the tests.

Testing was done to simulate different conditions of operation. In one series of tests, the track was driven over a flat surface and steel bars of three different shapes. In the flat surface tests, the track was driven over a piece of plexiglass so that the deformation of the pad could be observed from the underside of the track. The flat surface tests provided information on operating conditions in which the bottom surface of the pad is uniformly loaded (conditions such as a paved road). The three different steel bars simulated rigid obstacles that a track pad might encounter in cross-country terrain. The three bars had the following cross-sections: square, round, and L-shaped. The different shapes provided an interesting comparison of degrees of load concentration due to contact with a rigid obstacle.

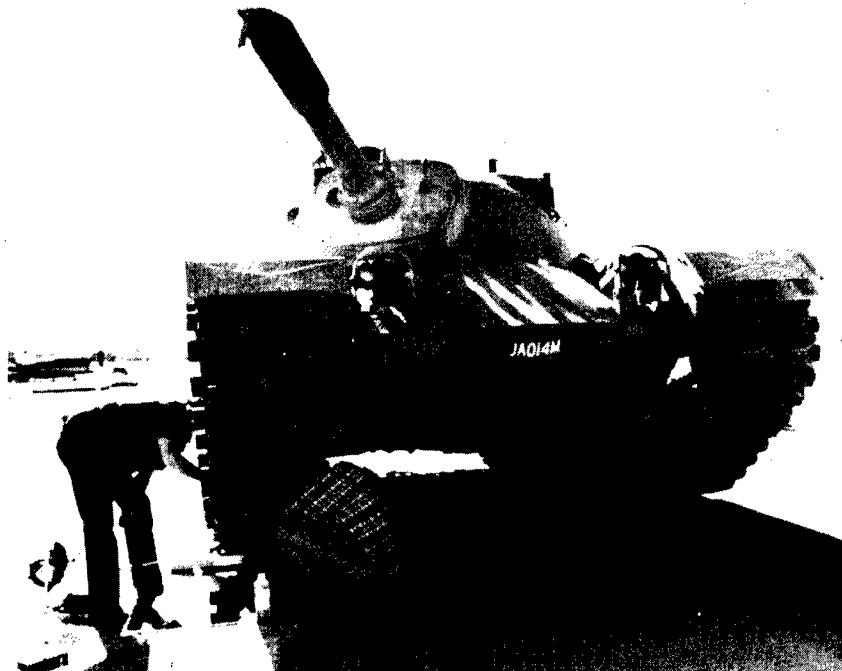
Figure 2. Experimental setup used in the pad deformation studies (View 2).

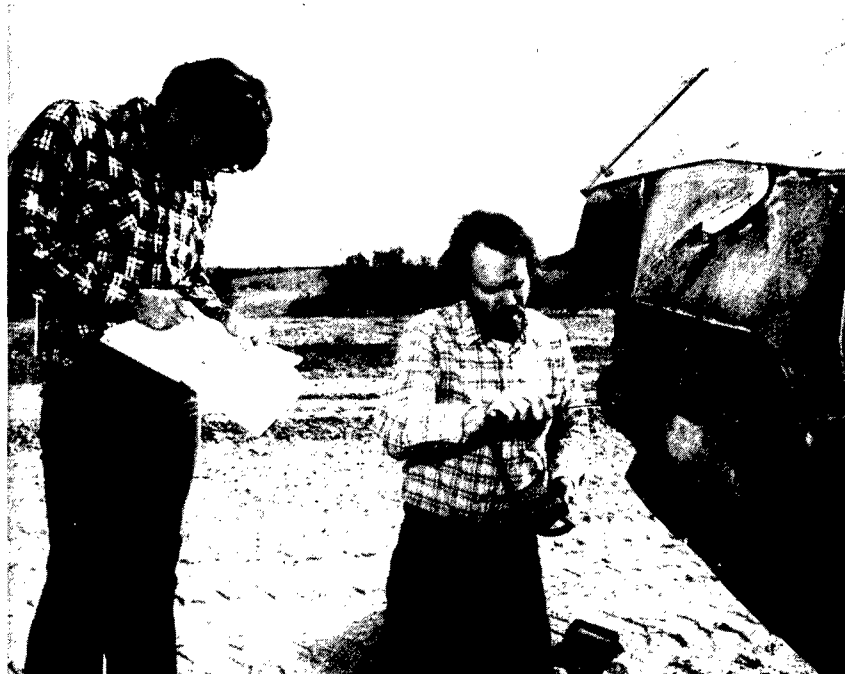
Figure 3. Surface temperature measurements being taken with the commercial surface thermometer.

The temperature measurement studies were undertaken to obtain the surface and internal temperature versus time response for T142 track pads. Measurements were taken for vehicle operation on each of the three standard courses at the Yuma Proving Grounds. The surface temperature were measured using a commercial surface thermometer. The pad interior temperatures were measured using a specially constructed thermocouple injection device. This apparatus pneumatically injects a fine needle (containing a thermocouple in the tip of the needle) to a preset depth in the track pad. Details of the thermocouple injection apparatus and the procedures used to calibrate this device and the commercial surface thermometer have previously been reported⁽¹⁾. Figures 3 and 4 show the apparatus being used in the field to measure the surface and internal temperature of a T142 track pad.

The operation procedure in this series of tests was to drive the tank and stop at predetermined distances to measure the surface and internal temperatures for a given track pad. In addition, the physical condition of the pad was visually assessed. For the gravel and cross-country courses, testing was done on a track pad with no mileage at the beginning of the test. The tank was stopped for approximately 90 seconds so that temperature measurements could be made. During this time, no significant change in temperature was recorded.

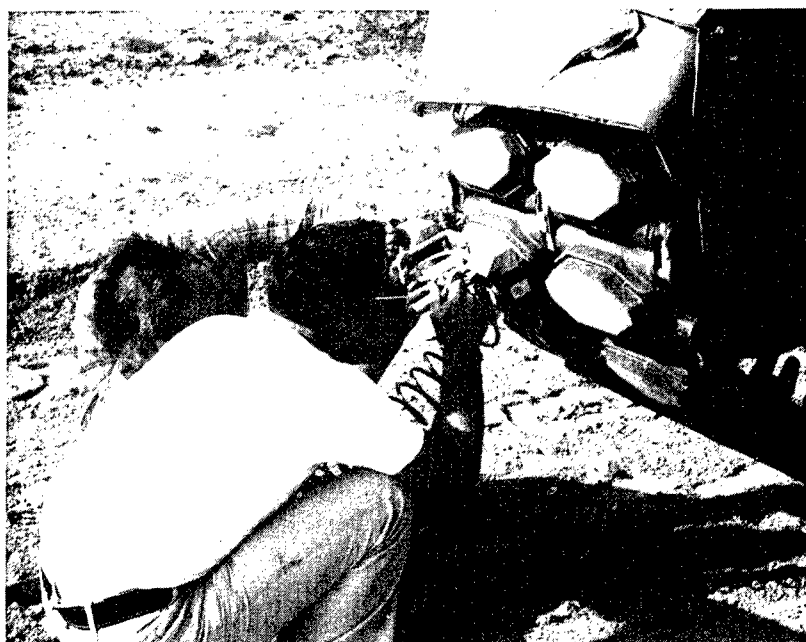
Figure 4. Interior temperature measurements being taken with the thermocouple injection device.

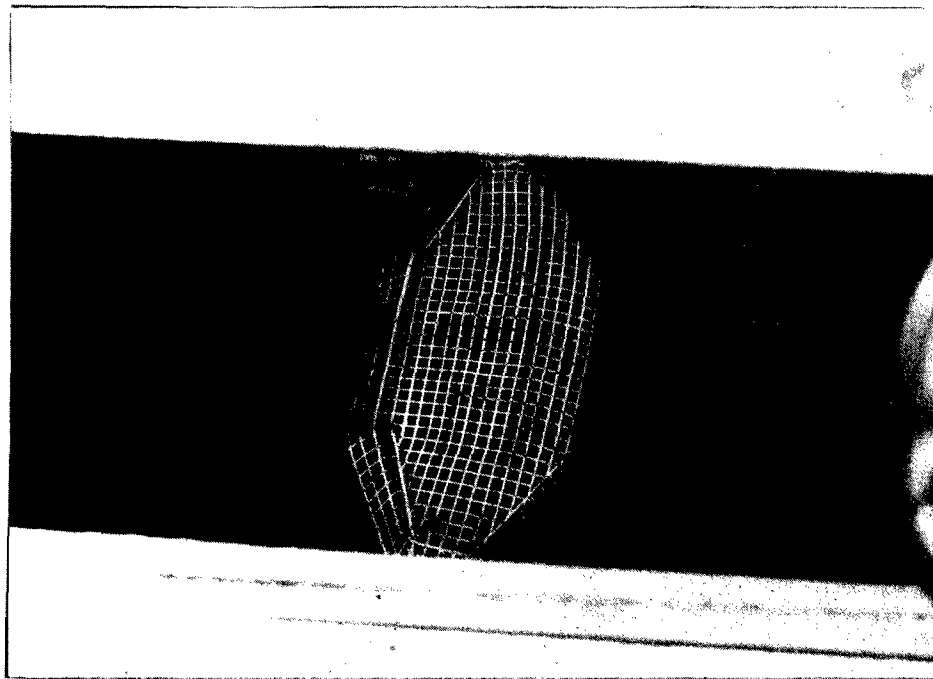
Figure 5 shows results for the flat surface test at 125°C . It is important to note that, as expected, the deformation was restricted to the plane perpendicular to the axis of the binocular tubes (no deformation along the long axis of the pad). Thus, the assumption of plane strain used in the mechanical model of the track is valid. One should also note the large frictional constraint that exists at the bottom of the pad. The side surfaces bulged but no deformation was evident along the bottom. This was also seen in the mechanical model.

Figure 5. Photograph from the bottom of the pad showing pad deformation during contact with a flat surface. Pad temperature is 125°C .

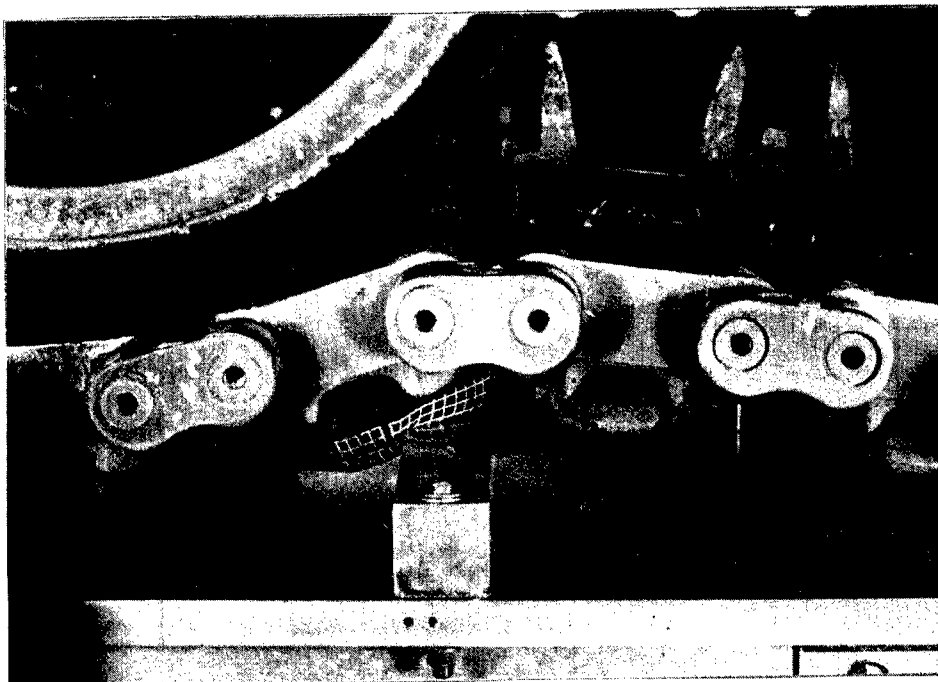
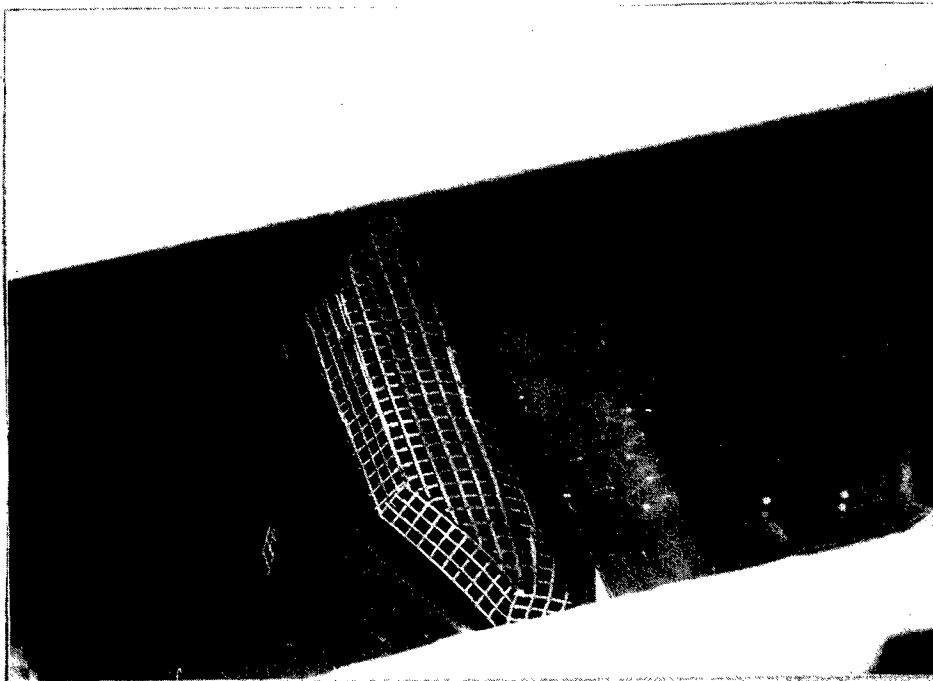
Figures 6 and 7 show pads that have been heated to 97°C and 112°C , respectively, and run over the square obstacle. Figure 6 is taken from the side of the track, while Figure 7 is taken from the bottom. During contact with a rigid flat obstacle such as this, the track pad would slip and scrub over the surface. Only minimal slippage was observed in the flat surface tests. This "scrubbing" effect produced an applied shear stress on portions of the bottom surface of the pad. This shear stress produced tensile stresses and stains in the track pad. Figure 7 shows the tensile strain in the bottom surface of the pad. Tests done at different tank speeds showed that the amount of scrubbing increased with increasing tank speed. Data in the literature shows that cuts in rubber tend to propagate largely in response to tensile stresses^(2,3). Thus, one would expect this "scrubbing" process to play a significant role in the chunking phenomena observed in cross-country terrain.

Figure 6. Photograph from the side of the pad showing pad deformation during contact with a square obstacle. Pad temperature is 97°C .

Figure 7. Photograph from the bottom of the pad showing pad deformation during contact with a square obstacle. Pad temperature is 112°C .

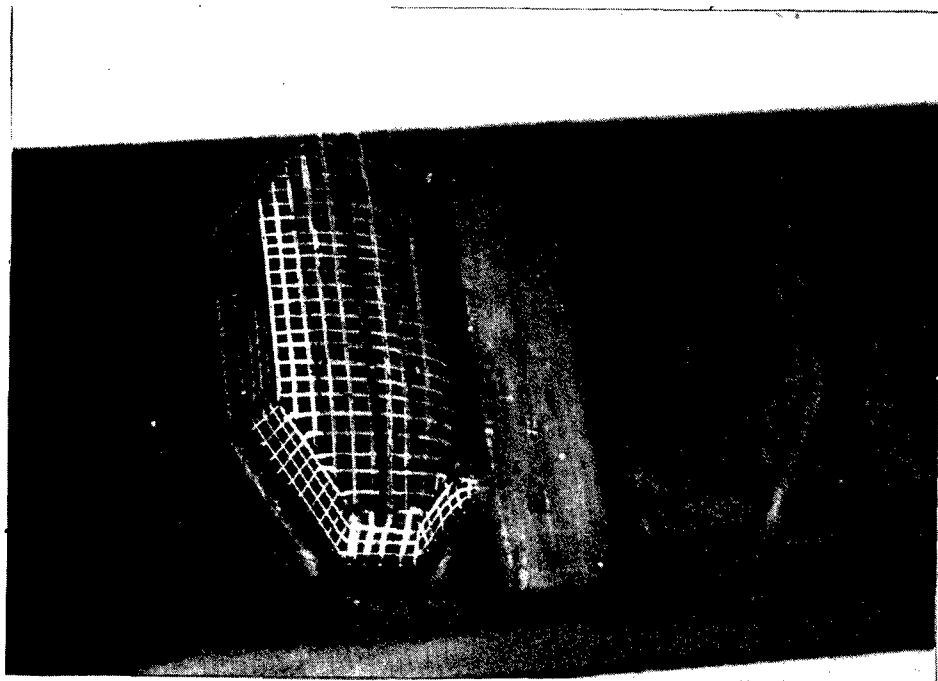
In Figure 8, we show a piece of rubber being torn from a track pad as it contacts the rigid obstacle.

Figure 8. Photograph showing rubber being cut due to contact with the square obstacle. Pad temperature is 30° C.

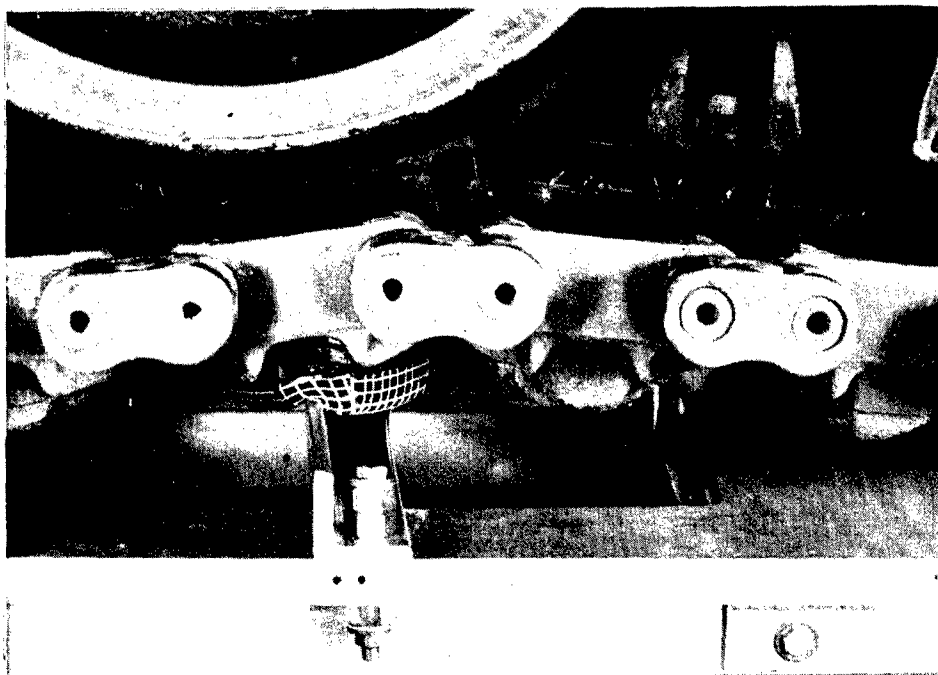
Figures 9 and 10A-K show the large deformation that takes place when a pad strikes a highly localized rigid obstacle (L-shaped bar). In Figure 9, the pad is at ambient temperature while in Figures 10A-K the pad is at 96° C. Figures 10A-K show a sequence of photographs taken as the roadwheels of the tank rolled over the track section of interest. The tension in the track from the drive sprocket is responsible for the asymmetric deformed geometry of the pad. Because the bar is deeply embedded in the pad, the tendency for scrubbing is reduced in this operating scenario relative to that for the square bar.

Figure 9. Photograph from the side of pad showing deformation during contact with the L-shaped obstacle. Pad temperature is 30°C .

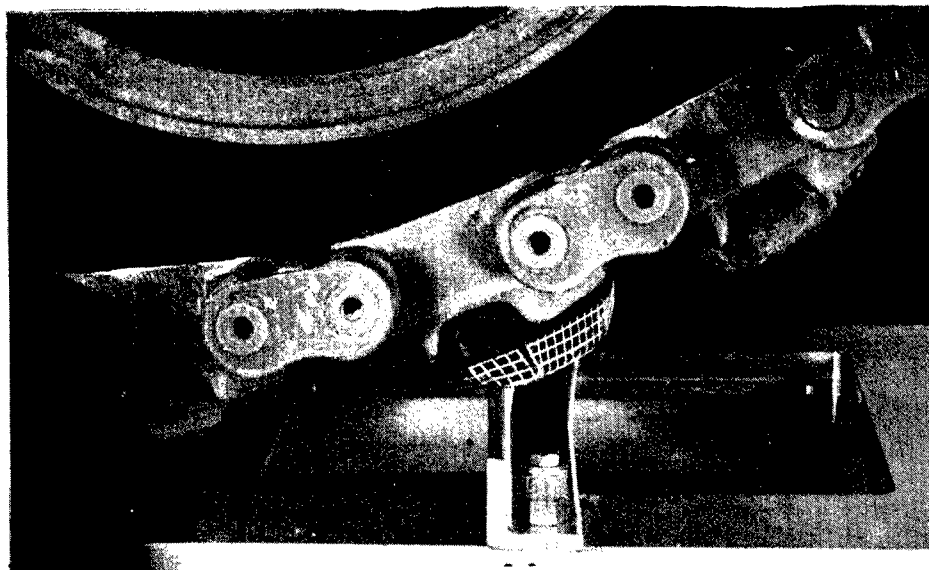
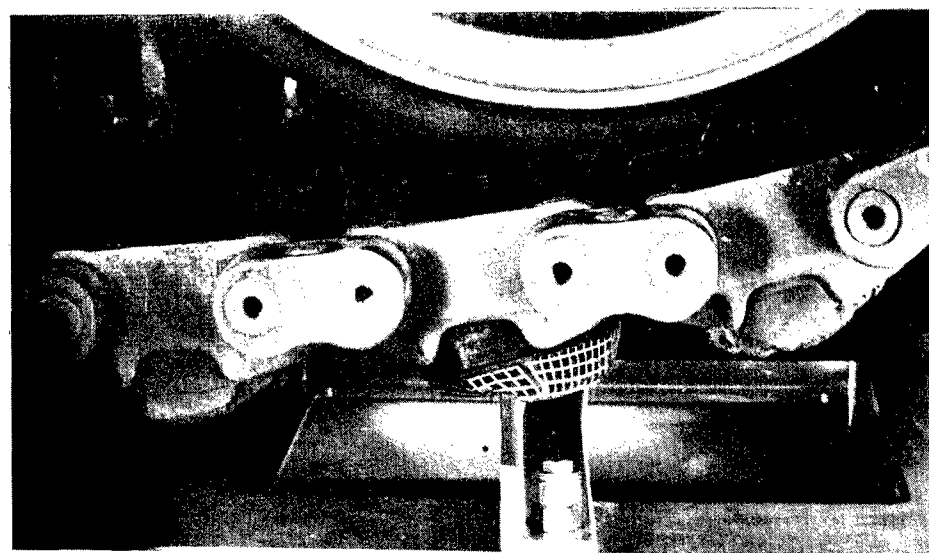
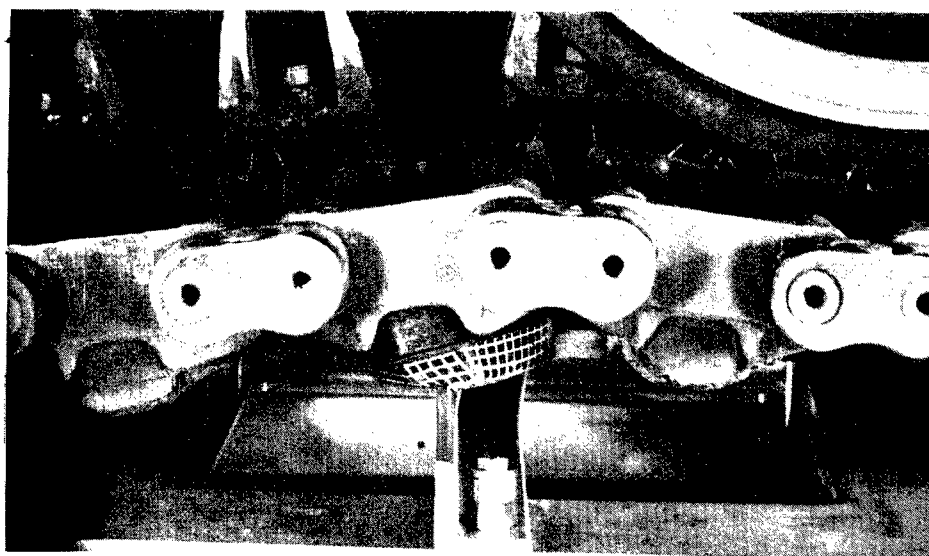
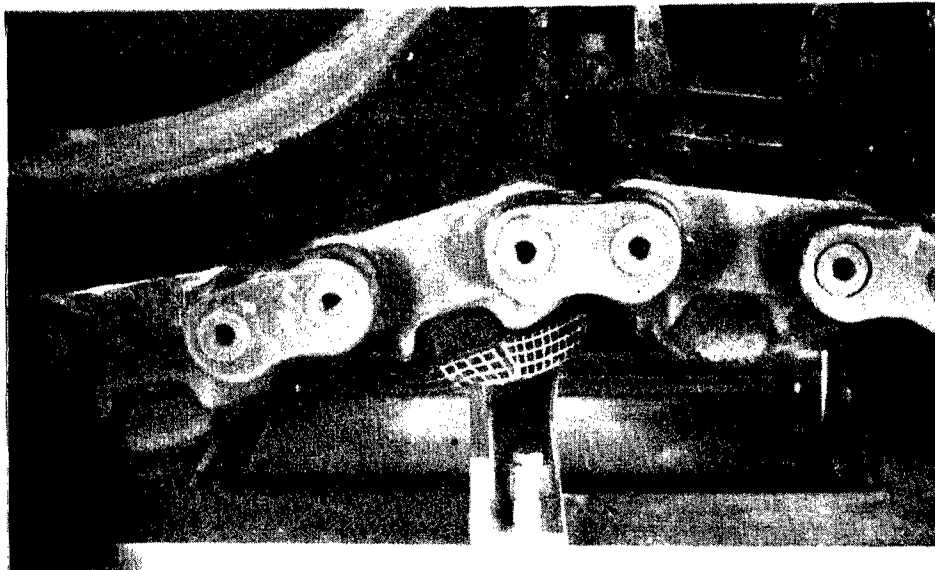
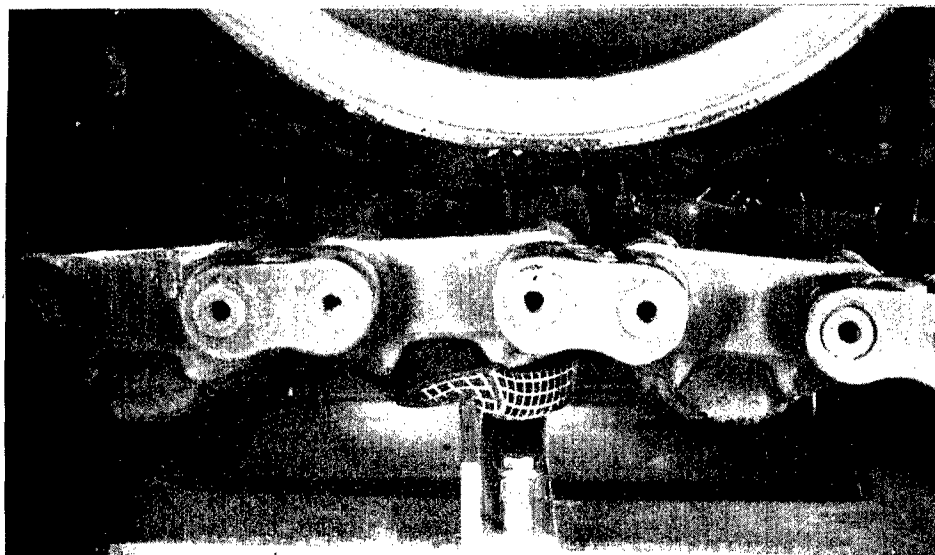
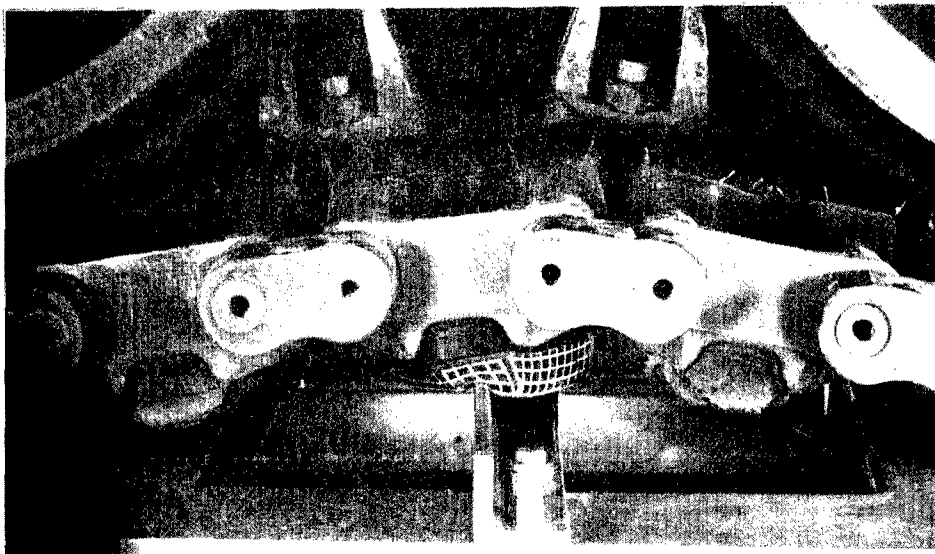
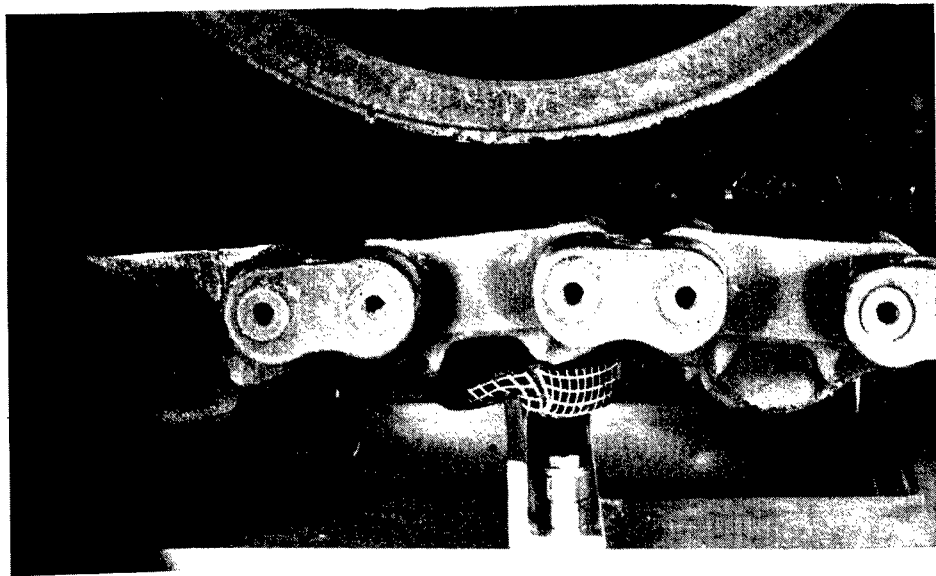
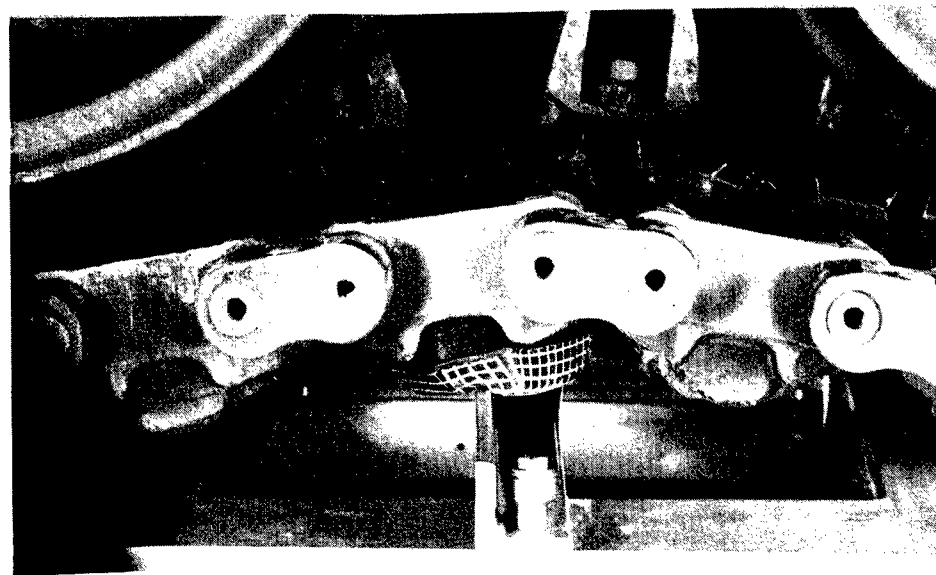
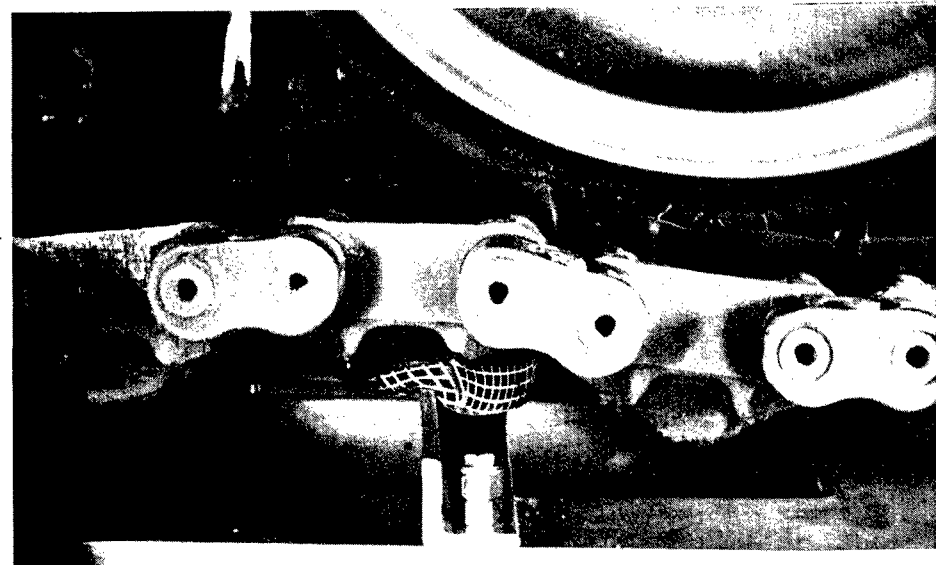
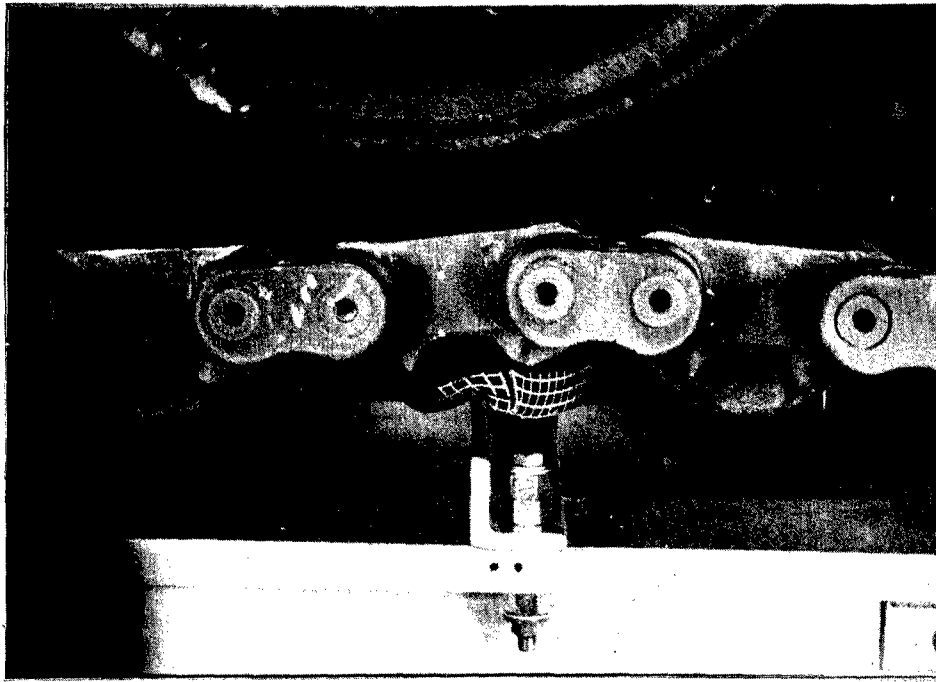
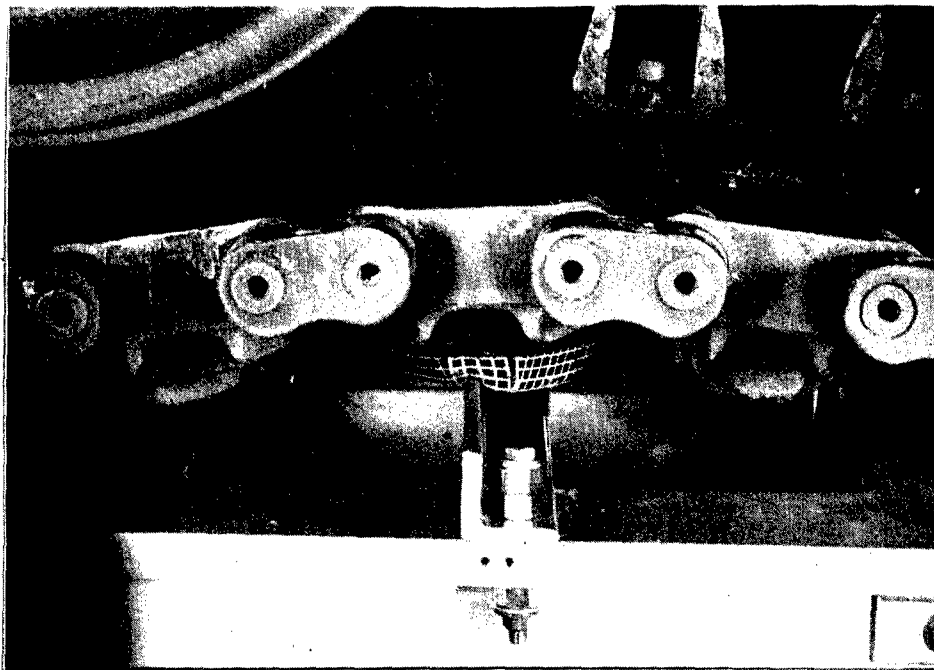
Figures 10A, B, & C.

Photographs from the side of the pad showing deformation during contact with the L-shaped obstacle. Pad temperature is 96°C .

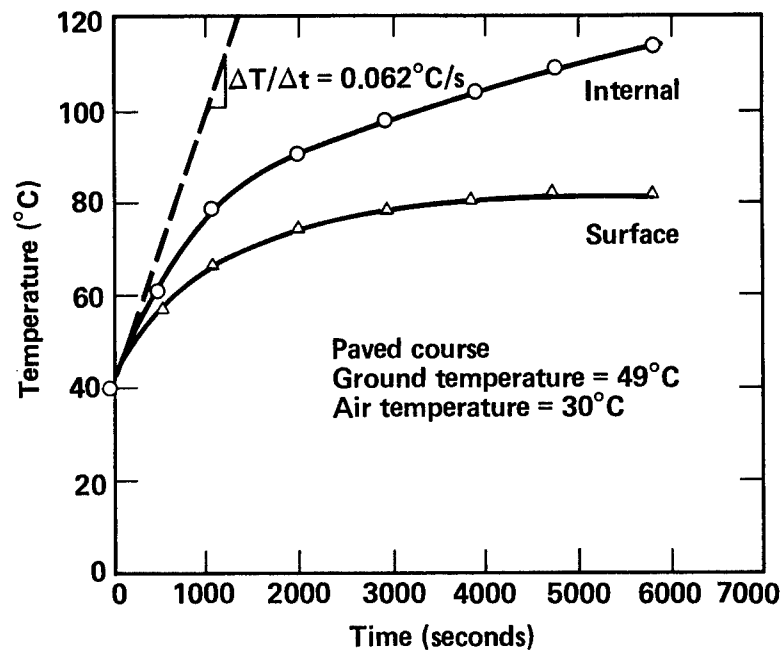
Test results of pads from Vendor C are shown in Figure 11 for both surface and internal temperatures. Data are expressed as temperature versus time. All Vendor C pads tested exhibited essentially the same temperature-time response. Thus, the present data indicates that accumulated mileage has little effect on the temperatures achieved in pads. Further, during the few minutes stop-time in which measurements were made, no appreciable temperature drop was observed. Surface temperature data for pads from the three vendors correlated very closely (maximum deviation was 1° C or 2° F). However, for the

Figure 11. Temperature-time response for surface and internal points of a track pad as measured on the paved course.

interior temperature data (taken 15.9 mm (0.625 in.) below the surface) pads from the three manufacturers showed some variation. Pads from Vendors B and C exhibited the same temperature-time response and showed a maximum temperature deviation of 7°C (13°F) from the pads of Vendor A.

The heat generation rate at ambient temperature was also calculated from the data in Figure 11 and found to be 108 kW/m^3 ($10.4 \times 10^3\text{ Btu/hr ft}^3$). As discussed previously, the heat generation rate is proportional to the slope of the temperature-time curve at $t = 0$ seconds.

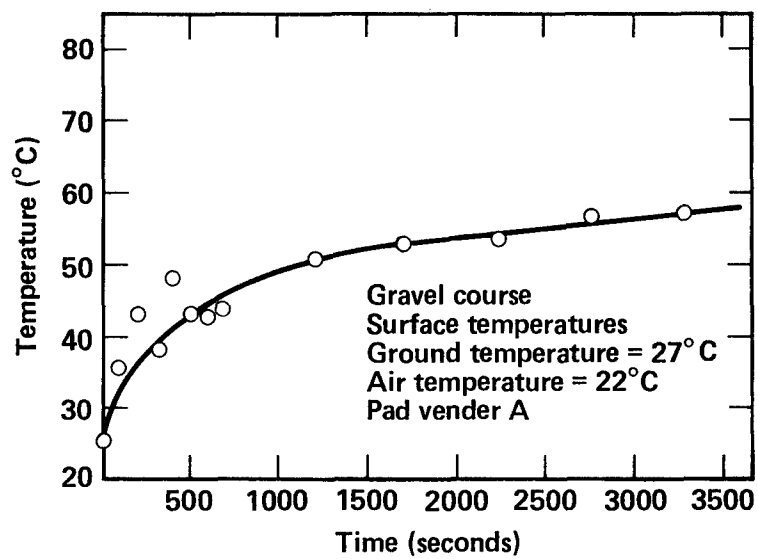
The surface temperature data are plotted in Figure 12. Considerable scatter was noted in the beginning portion of the test. The interior temperature results are plotted in Figure 13. As expected, the temperature taken 25.4 mm (1.0 in.) below the surface are higher than those 15.9 mm (0.625 in.) below the surface. The heat generation rate was calculated to be 233 kW/m^3 ($225 \times 10^3\text{ Btu/hr ft}^3$). A comparison between results obtained on the three courses will be given later.

Figure 12. Temperature-time response for the surface of a pad as measured on the gravel course.

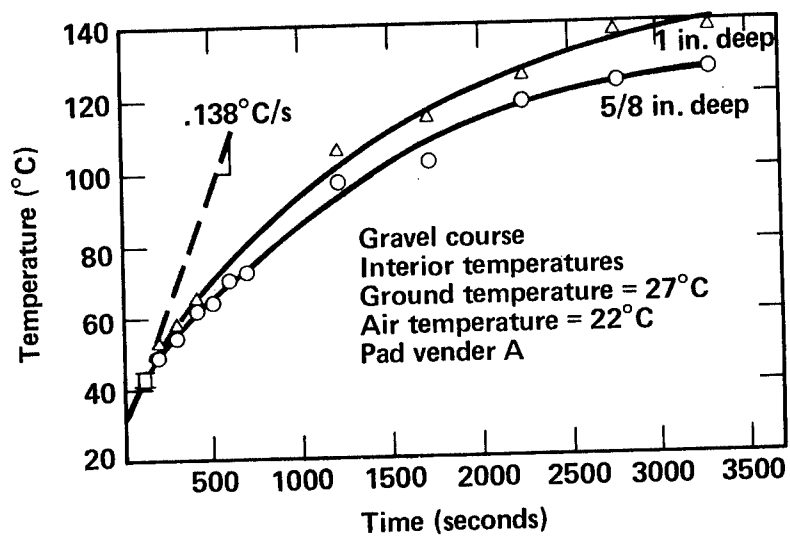
Figure 13. Temperature-time response for two interior locations in a track pad as measured on the gravel course.

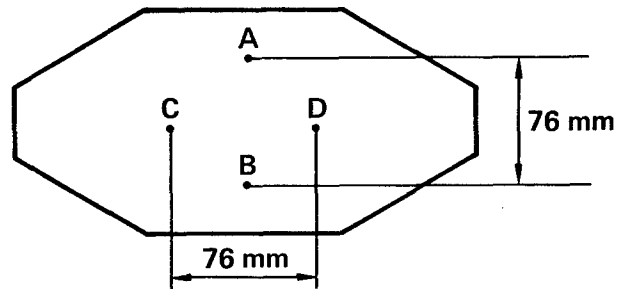
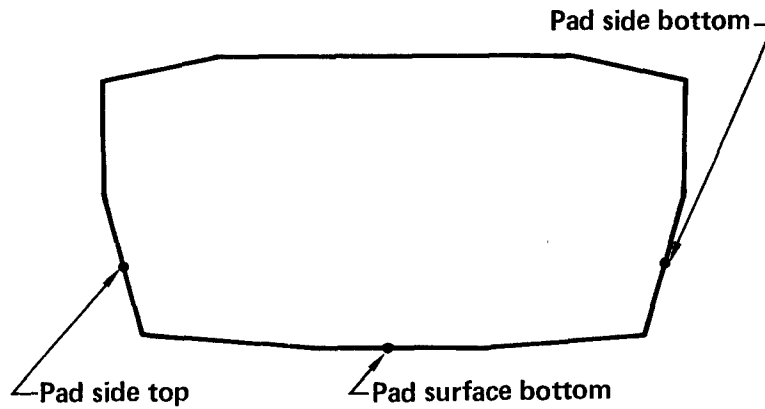
Data on the cross-country course were taken in a number of pad locations. Figure 14 shows the four different interior pad locations and three different surface pad locations that were studied. All interior measurements were taken at 15.9 mm (0.625 in.). The field data are given in Tables 2 and 3. The speed of the vehicle varied considerable during these tests. The tank climbs hills on the cross-country course at speeds estimated at approximately 2.2 m/s (5 mph). However, descending from a hill, vehicle speed was estimated to exceed 9 m/s (20 mph). The average speed during the tests was 7.23 m/s (16.2 mph).

Locations for interior pad temperature measurements

All measurements 15.9 mm deep

Points A, B, C, D equidistant from pad center

Locations for surface temperature measurements

Figure 14. Pad locations for surface and internal temperature measurements made on the cross-country course.

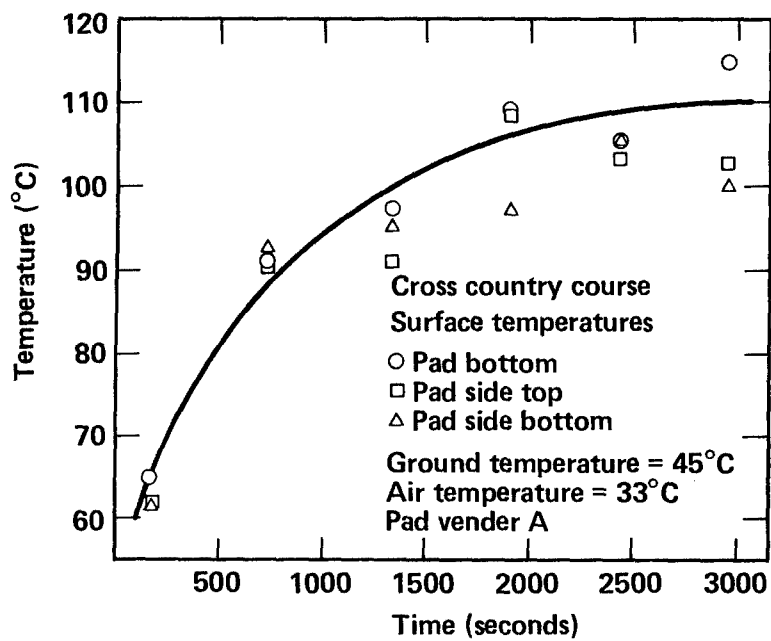
The surface temperature data are plotted in Figure 15. All surfaces studied produced essentially the same temperature-time response. The interior temperature data for Locations A and B are plotted in Figure 16 and for Locations C and D are plotted in Figure 17. Locations A and B showed that temperature-time responses differed by approximately 19°C (34°F) after 1900 seconds of vehicle operation. This was due to the difference in the heat generation rate at these two locations. The heat generation rate for Region B was 326 kW/m^3 ($31.5 \times 10^3\text{ Btu/hr ft}^3$) while the rate for Region A was 253 kW/m^3 ($24.5 \times 10^3\text{ Btu/hr ft}^3$). Location B struck the ground or any obstacle before Location A and is believed to experience more deformation. This produced the higher heat generation rate. It is important to note that the measured temperatures at Region B exceed 150°C after 2400 seconds and were still increasing, although at a decreasing rate. The temperature-time response for Regions C and D were essentially the same. This later result is important since it shows that even for the complex situation of cross-country terrain, there was no thermal gradient along the long axis of the pad. Thus, all heat flow was in the plane perpendicular to the axis. This verified the planar heat flow assumption used in our thermal modeling of the T142 track.

Figure 15. Temperature-time response for three surface locations on the pad as measured on the cross-country course.

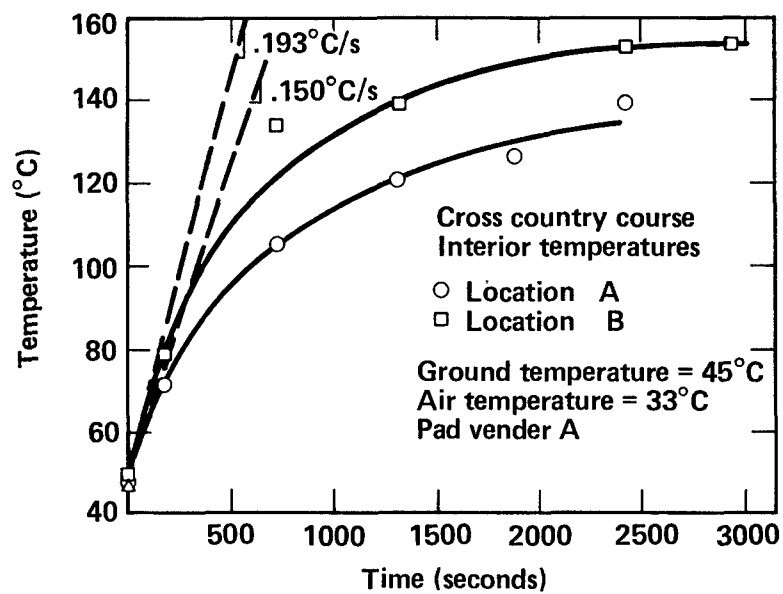
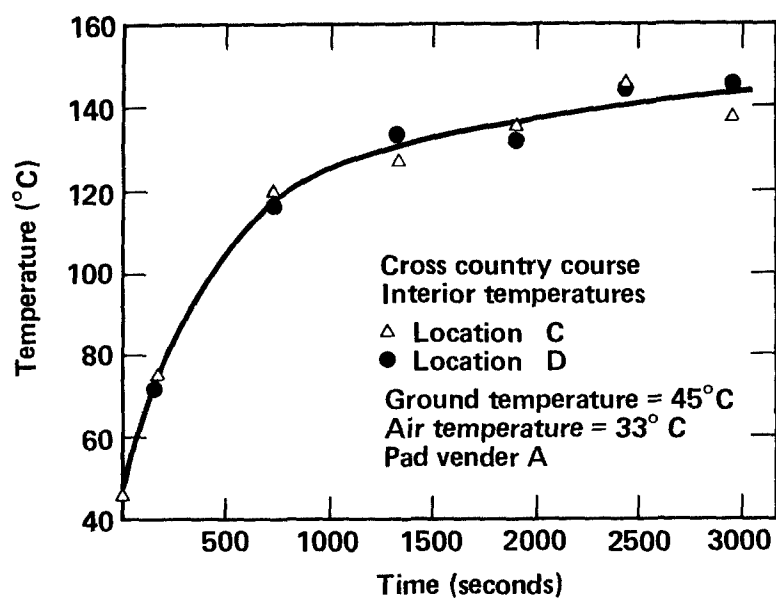
Figure 16. Temperature-time response for interior Locations A and B as measured on the cross-country course.

Figure 17. Temperature-time response for interior Locations C and D as measured on the cross-country course.

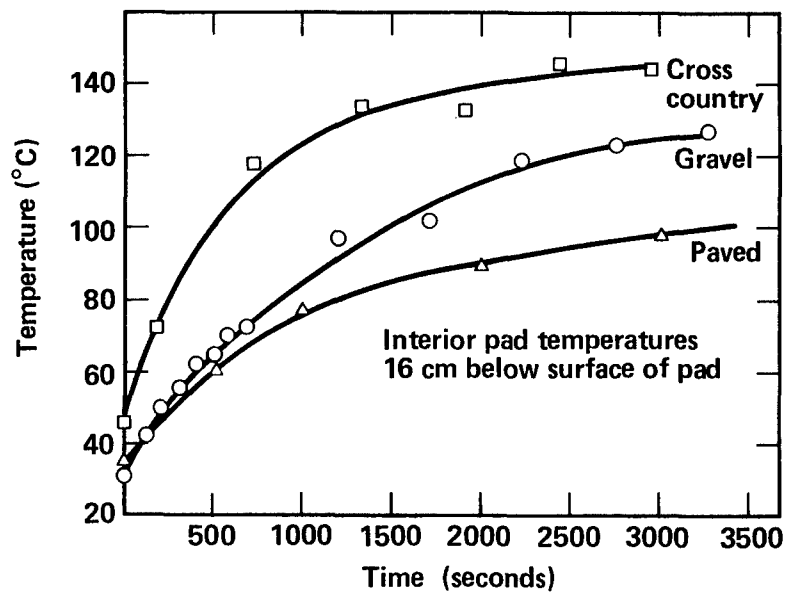
In Figure 18, the internal temperature histories (measured 15.9 mm (0.625 in.) below the pad surface) measured on the three courses have been plotted on a common set of axes. The temperatures were highest in the cross-country tests and lowest in the paved surface tests. In Table 4, we have compiled the heat generation rates measured in these tests. It is important to note the heat generation rates reported in Table 4 are valid at the initial temperatures of the pads. The heat generation rates decreased as the

Figure 18. Temperature-time response for the pad interior as measured on the three test courses.

temperature of the pads increased. The cross-country testing produced the highest rate while the paved surface testing produced the lowest rate. This occurred despite the fact that the speeds during cross-country testing were lower than in the other tests. This higher heat generation rate was due to the larger deformations put into the track pads as the tank climbed hills, descended from hills, and negotiated obstacles. It should be noted that one of the primary factors producing the deformation that caused the heat generation rate in the gravel tests was probably the numerous turns that the vehicle must make in negotiating the course. Thus, it appears that the primary driver for the internal temperature of the pads is the heat generation rate.
